# **Examination of Failed One Inch Black Iron Pipe Natural Gas Service Line, Iowa Public Service Company, Eagle Grove, Iowa**

T. Robert Shives

August 30, 1973

Failure Analysis Report

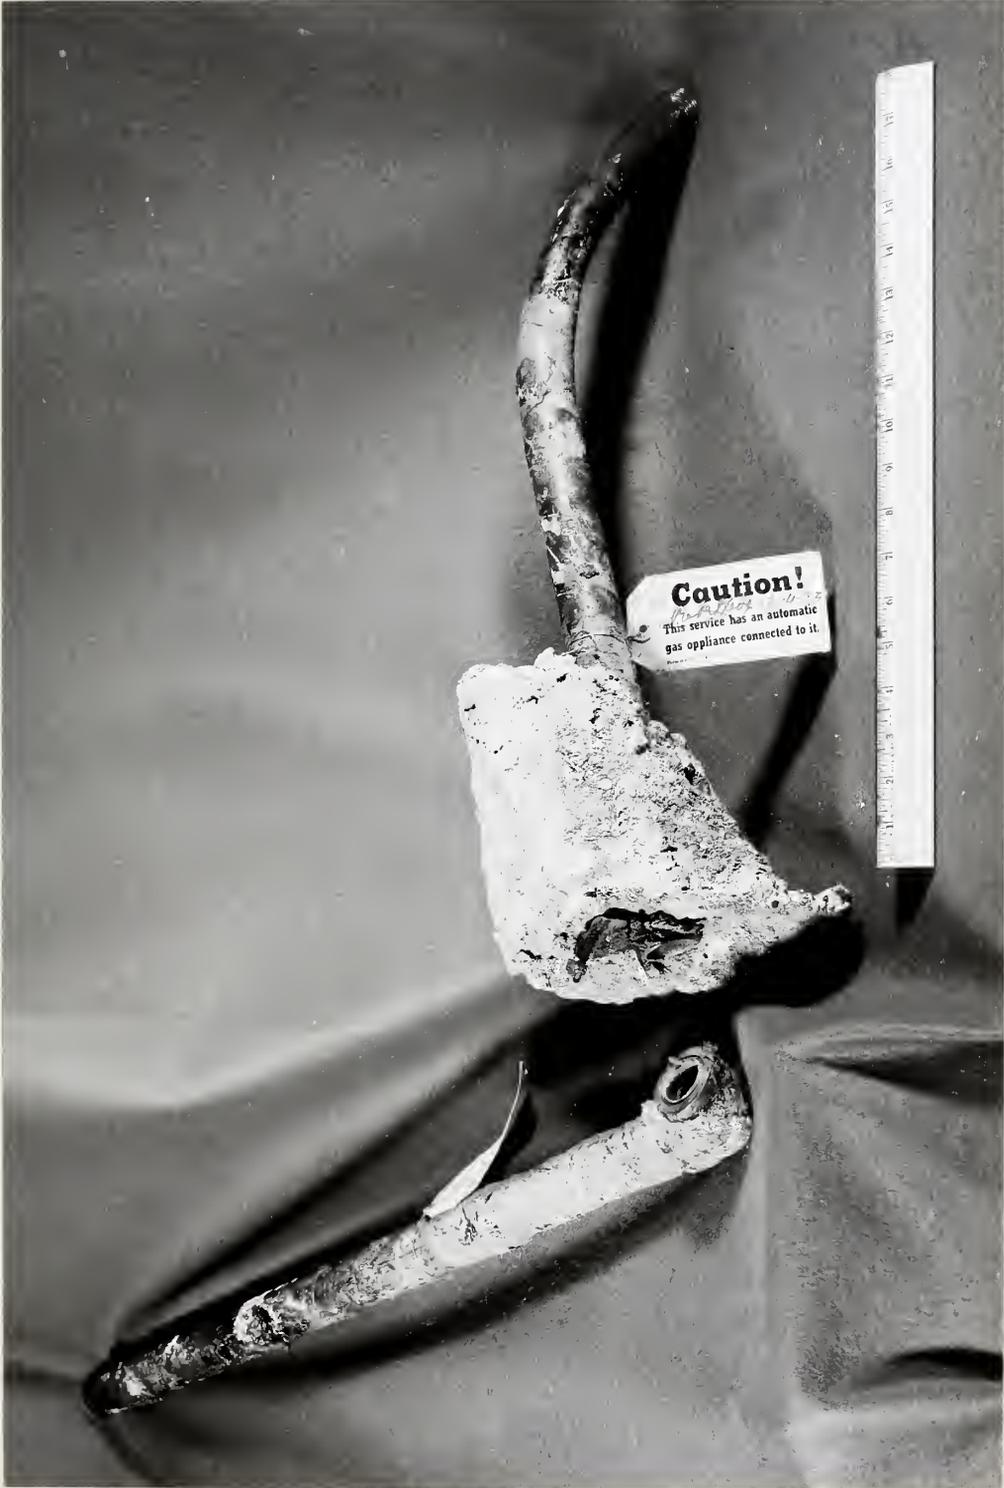
Figure 1. Submitted failed natural gas service line pipe parts as received. ~ X 1/4

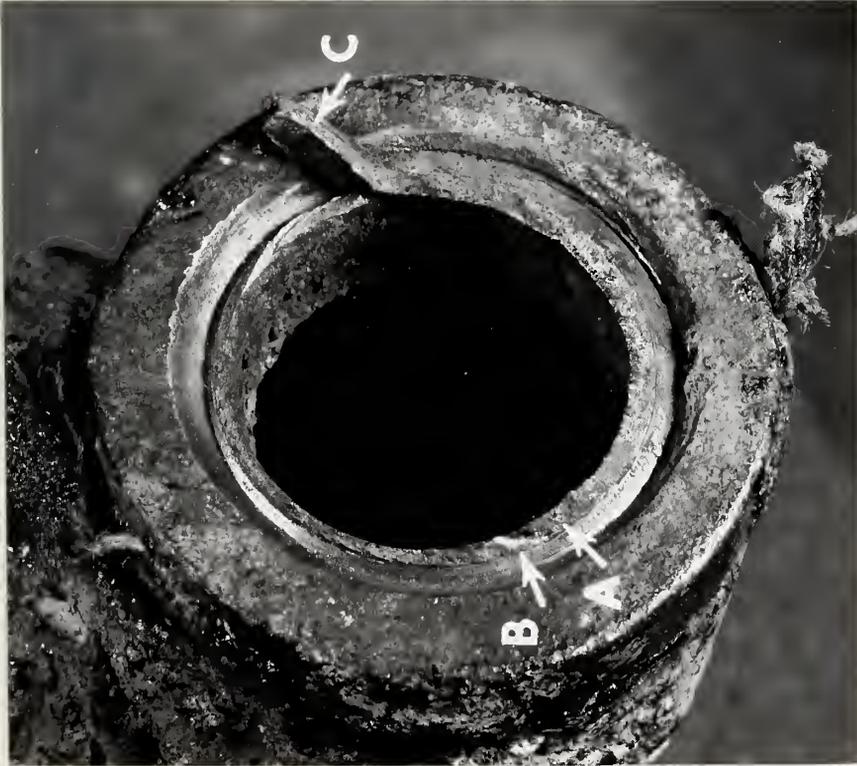
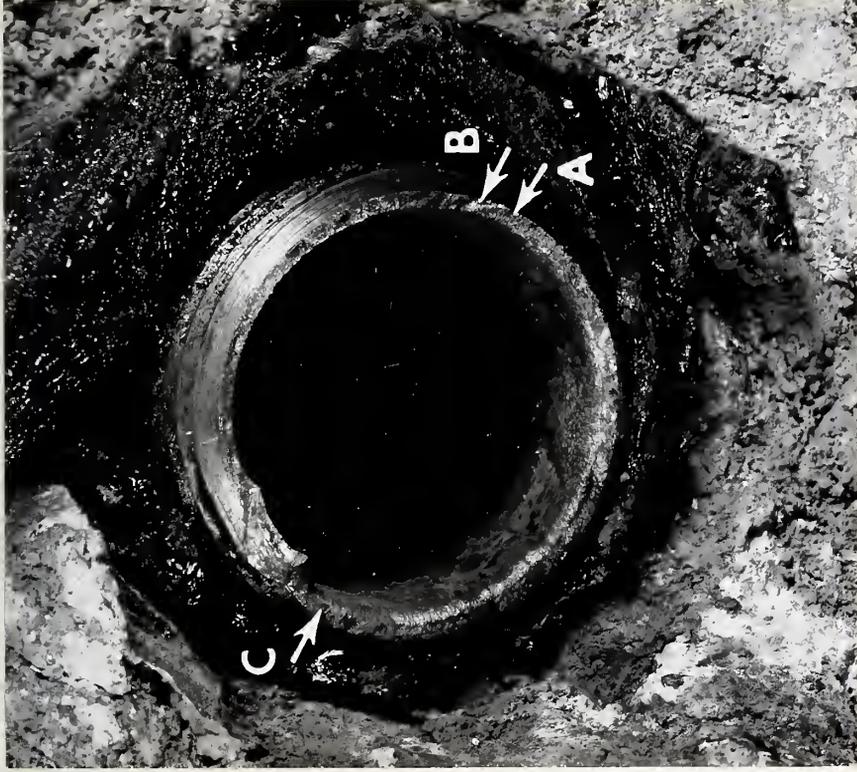
The two opposing fracture surfaces of the submitted failure are shown as received in figure 4. The pipe had fractured in the threaded end at the root of a thread at the end of a 90° elbow as can be seen in figure 4a. The short part of the fractured piece remained in the elbow.

Both of the fracture surfaces were covered with corrosion product (rust) which for the most part appeared to be superficial except for the region discussed in Section 1.2 where the rust appeared to be denser. This region was between the 6 o'clock and 9 o'clock positions when looking into the downstream end of the 90° elbow with the pipe positioned as it had been in service. The heaviest concentration was at about the 7-7:30 o'clock position (arrow A, figure 4a). The dense rust appeared on the mating position of the opposing fracture surface (arrow A, figure 4b). There were mating areas on both fracture surfaces adjacent to the region of densest rust which appeared to have suffered mechanical damage (arrows B, figure 4). The apparent last part to fail is indicated by arrows C, figure 4.

After the submitted fracture surface was cleaned, the appearance of it and the appearance of the NBS produced fracture surfaces were very similar. The tearing and deformation at the apparent last part to fail in the submitted fracture (arrow C, figure 4a) more closely approximated that of the NBS bend test fractures than those produced by uniaxial tensile testing. Since the rust was easily removed from the submitted fracture by ultrasonic cleaning with water and detergent, the rust over the entire fracture surface was apparently superficial.

Figure 4. Fracture surfaces of the submitted failure as received. Arrows A indicate areas of dense rust; arrows B indicate areas of mechanical damage; arrows C indicate apparent last part to fail. X 2

a. Fracture surface of part of the horizontal pipe which remained in the 90° elbow. The elbow was attached to the riser pipe.

b. Fracture surface of the remainder of the horizontal pipe.

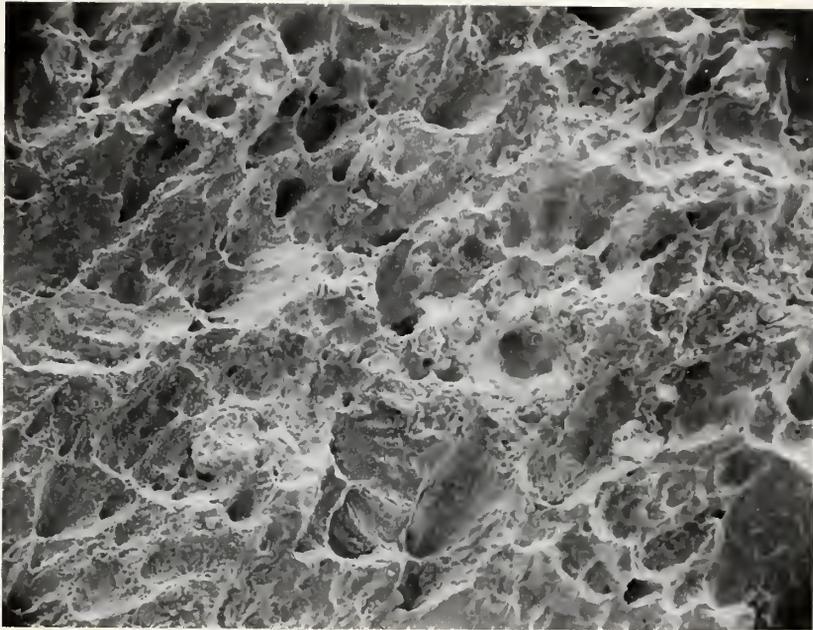
The submitted failure and the NBS produced failures "B" and "D" all exhibited dimpled rupture over essentially their entire fracture surfaces indicating that all the fractures were ductile in nature. Scanning electron photomicrographs (SEM's), showing features representative of the submitted fracture, are shown in figures 5 through 9. Figures 5 and 6 were taken in an area which appeared to exhibit the densest rust (area A, figure 4b). They show dimpled rupture. Figure 7 (area B, Figure 4b) shows dimpled rupture with considerable mechanical damage. The edge of the thread root can be seen near the bottom of the figure. Figures 8 and 9 were taken in two different areas away from that exhibiting the dense rust. Dimpled rupture again is essentially the only fracture feature exhibited. No evidence was found to indicate the presence of a pre-existing crack.

Figure 5. SEM of the fracture surface of the submitted failure in the area of densest rust (area A, figure 4b) showing dimpled rupture. X 650

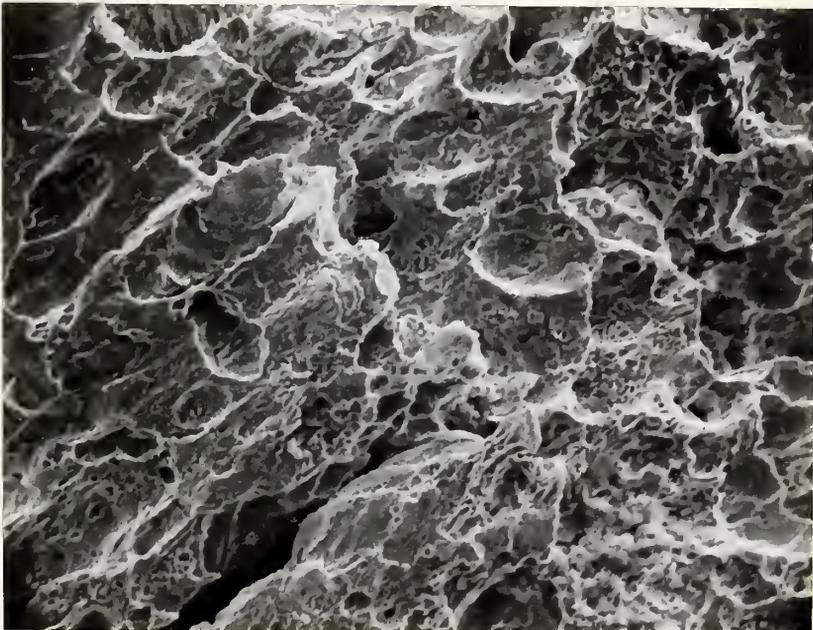
Figure 6. SEM of the fracture surface of the submitted failure in the area of densest rust (area A, figure 4b) showing dimpled rupture. A secondary crack can be seen in the lower left portion of the figure. X 1300

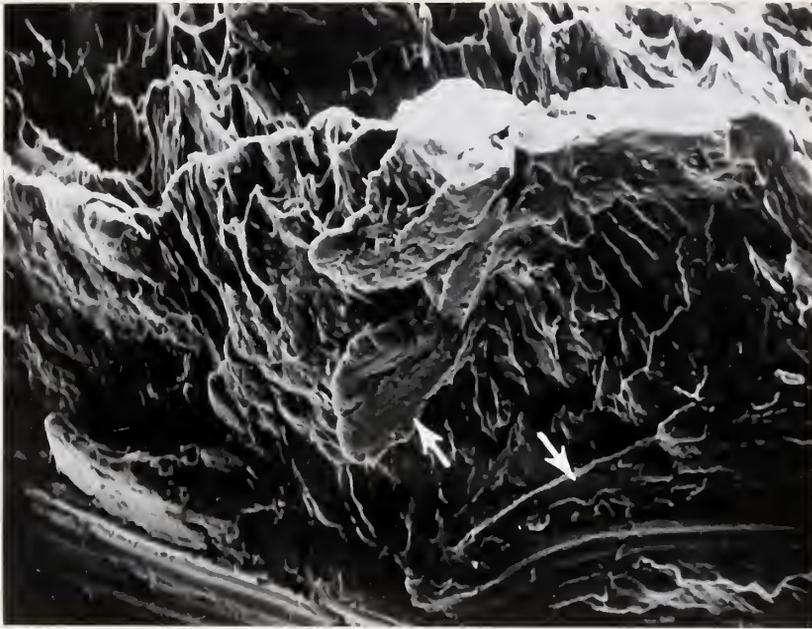
Figure 7. SEM of the fracture surface of the submitted failure in area B, figure 4b, showing mechanical damage (arrows) and dimpled rupture. Edge of thread root can be seen at lower left. X 550

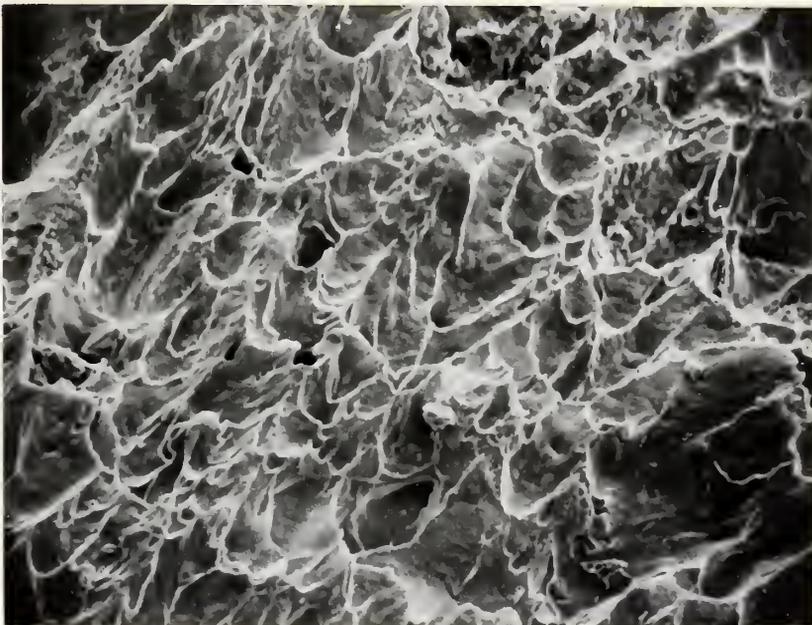
Figure 8. SEM of the fracture surface of the submitted failure in an area away from that containing the densest rust showing dimpled rupture. X 1100

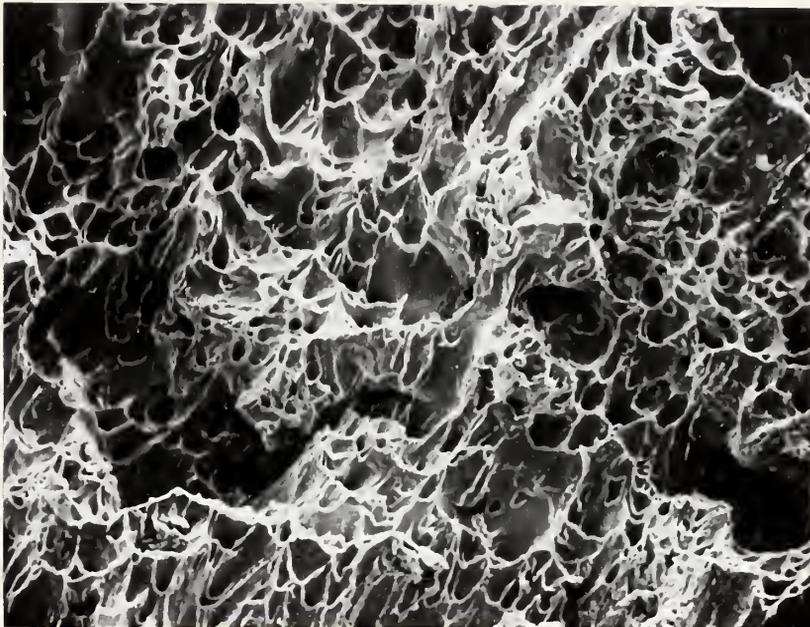
Figure 9. SEM of the fracture surface of the submitted failure in an area away from that containing the densest rust showing dimpled rupture. X 600

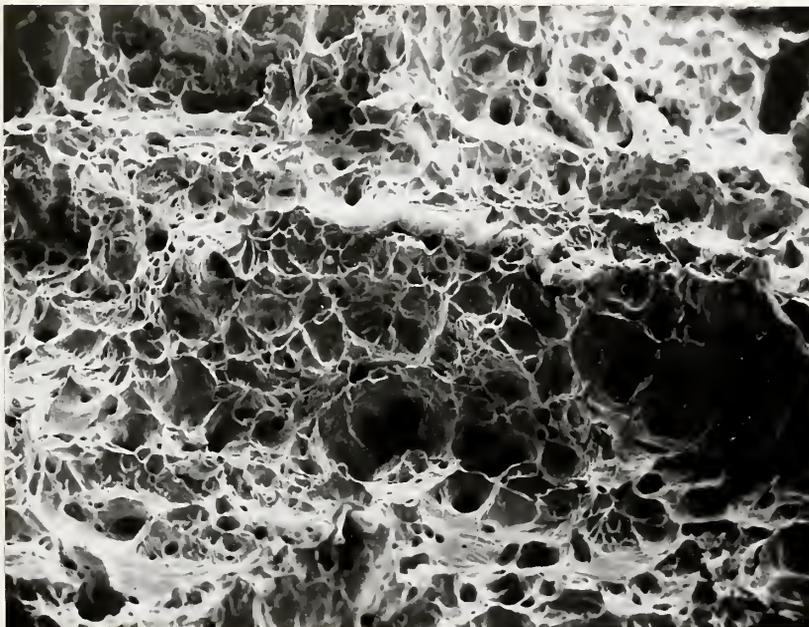
SEM photomicrographs representative of the fracture features of specimens from "B" and "D" are shown in figures 10 and 11, respectively. Both fracture surfaces exhibited essentially all dimpled rupture.

Figure 10. SEM of the fracture surface of the NBS produced bend test (test B) showing dimpled rupture. X 550

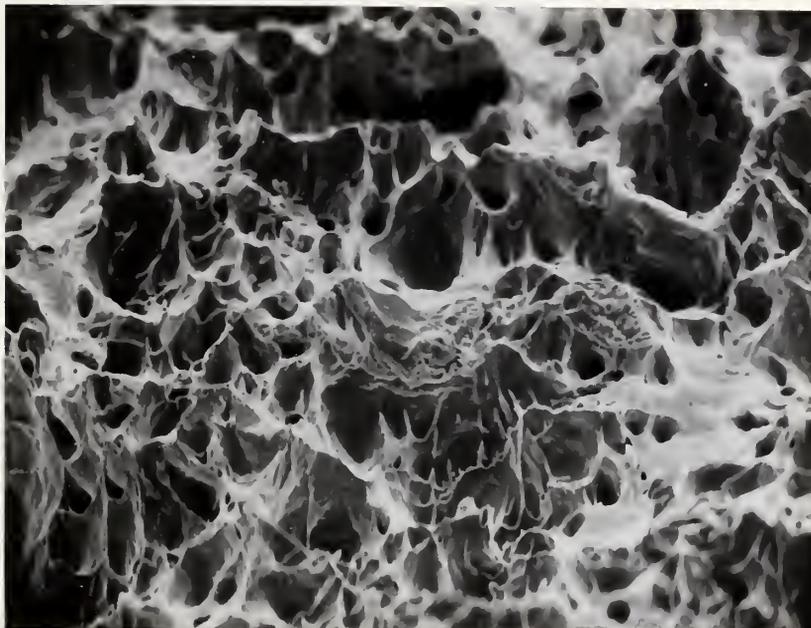
Figure 11. SEM of the fracture surface of the NBS produced uniaxial tensile test of material from the submitted failure (test D) showing dimpled rupture. X 750

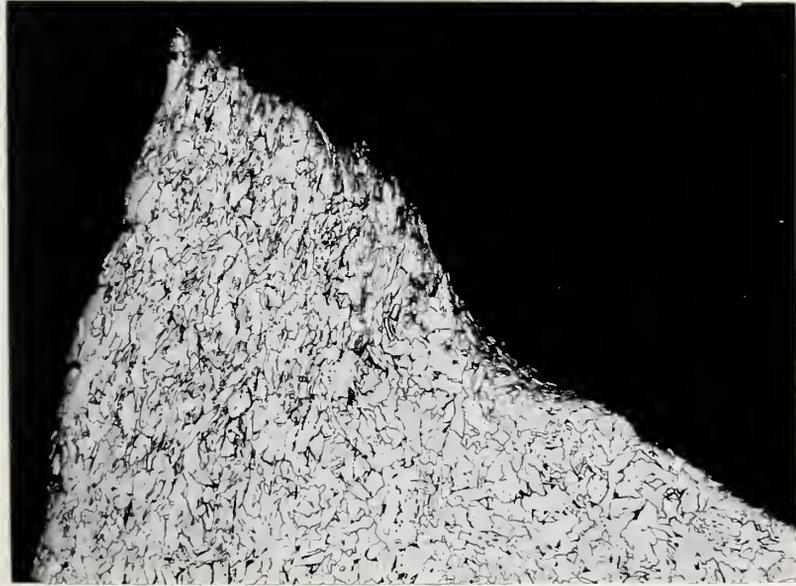
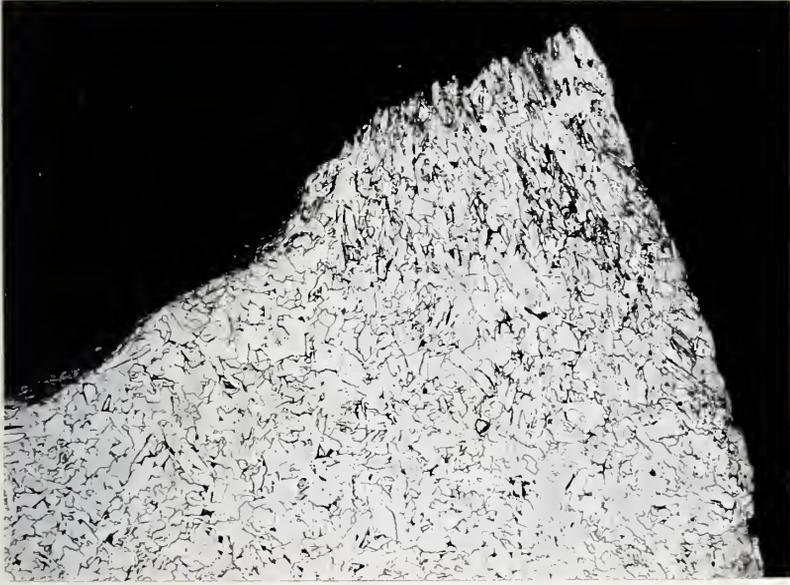
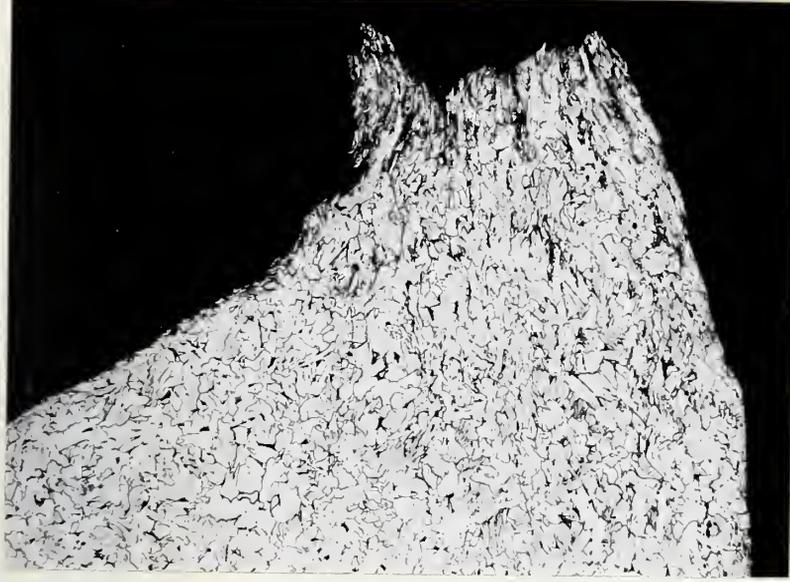
Low magnification photomicrographs of etched, longitudinal sections showing fracture profiles of the submitted failure and NBS produced failures "B" and "D" are shown in figures 13a, b, and c, respectively. The fracture profile in each case is shown vertically at the right of the figure. A considerable amount of deformation and necking can be seen in all three specimens, indicating ductility in the material. Some

Figure 13. Etched longitudinal cross sections showing fracture profiles. The inside wall surface of the pipe is horizontally at the top in 13a and horizontally at the bottom in 13b and 13c. The fracture profiles are vertically at the right in each case. Etch: ammonium molybdate. X 40

- a. Submitted failure.
- b. NBS bend test "B".
- c. NBS tensile test "D".

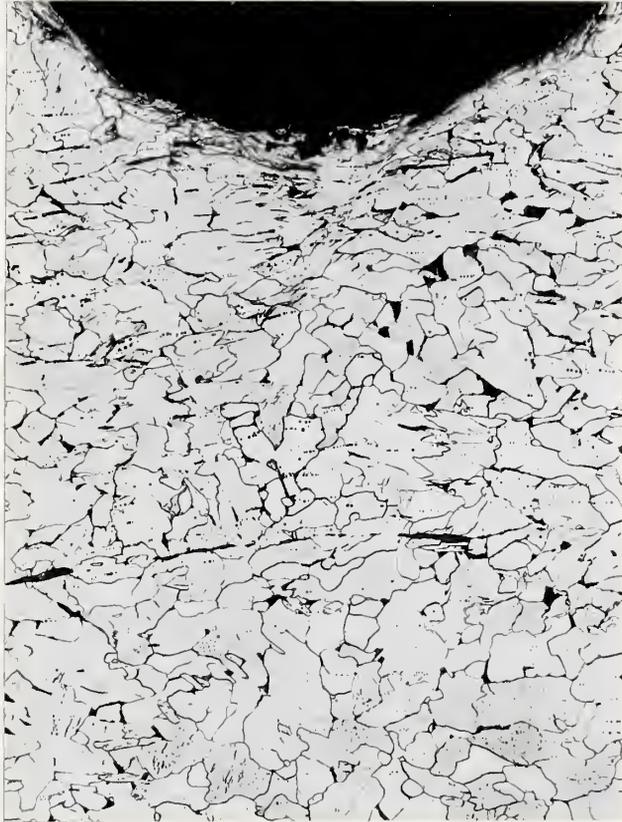
deformation was exhibited in the interior of the cross section adjacent to the root of the first thread beyond the fracture of the submitted failure (figure 14). Some of the deformation near the surface at the thread root appears to have been induced into the material by the threading operation. There are a few large stringers (inclusions) in this field which is not typical of the material in the submitted pipe.

Figure 14. Etched longitudinal cross section through submitted fractured pipe showing deformation at and near the root of the thread one thread removed from the fracture. Etch: ammonium molybdate. X 100

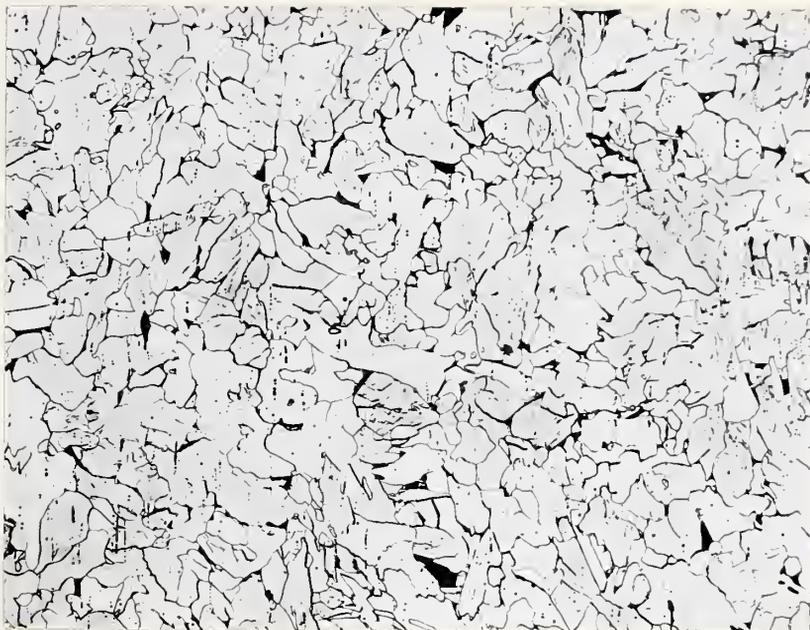
An etched microstructure representative of the material away from the deformed regions is shown in figure 15. The microstructure consists of ferrite (white) and a small amount of pearlite (dark patches). This is the microstructure of a normalized very low carbon steel.

Figure 15. Etched longitudinal cross section through submitted failed pipe showing representative microstructure which consists primarily of ferrite (white) and a small amount of pearlite (dark patches).  
Etch: ammonium molybdate. X 100

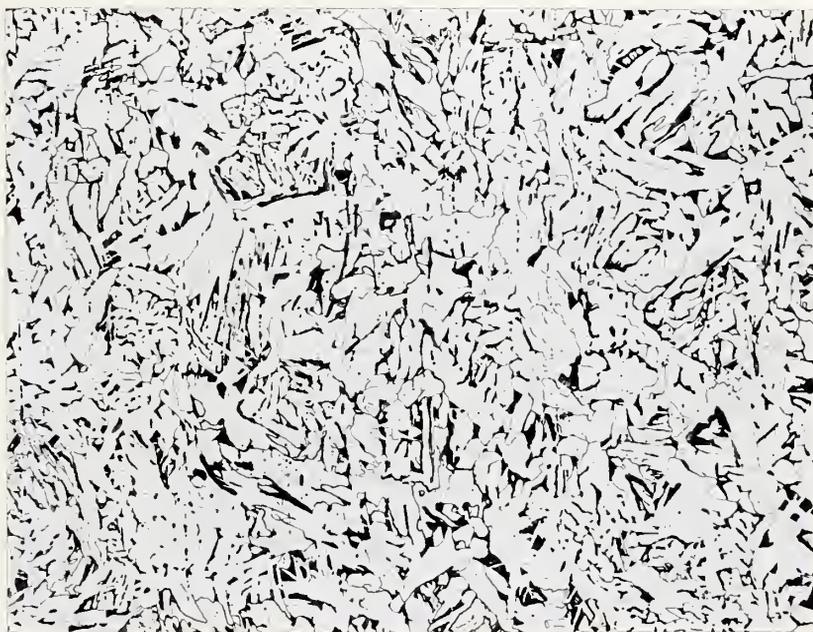
Metallographic examination of the stock black iron pipe material revealed a considerably higher inclusion content than found in the submitted material. An etched microstructure from a longitudinal cross section through the stock pipe is shown in figure 16. The microstructure consists of ferrite (white) and pearlite (dark patches). There is some evidence of a Widmanstätten structure. Comparison of microstructures indicates that the material from the stock pipe has a significantly greater amount of pearlite, and consequently, a significantly higher carbon content than that of the submitted pipe.

Figure 16. Etched representative longitudinal cross section through stock standard weight black iron pipe used for tests A and C. The microstructure consists of ferrite (white) and pearlite (dark patches). There is some evidence of a Widmanstätten structure.  
Etch: 3% Nital. X 100
